PRIMA

Service Information

Built-in Oven

LPR 9022

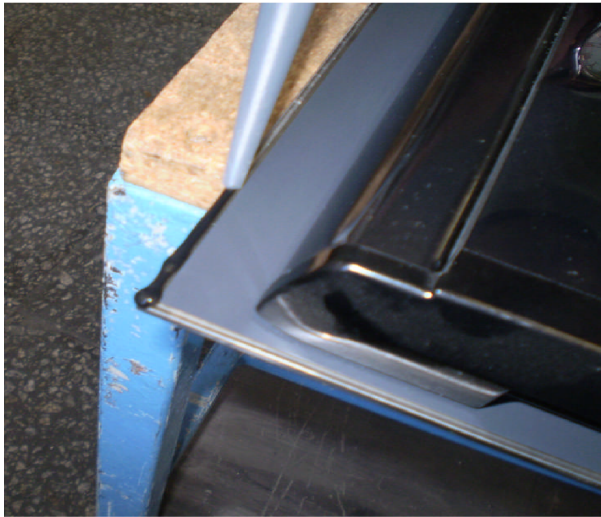
SUBJECT: Due to the gap between Door frame & Door, can it happen that customers cut their finger.

1. Remove the door from the oven
2. Place the oven door on an appropriate surface. Use a protection to avoid eventual scratches and aesthetical damages on the door!
3. Fill the gap with silicone
Silicon Service 12 NC
4801 211 01618
Use an appropriate dispenser size to be sure completely filling the gaps.
